ULTRASONIC PLY-BY-PLY DETECTION OF MATRIX CRACKS IN
LAMINATED COMPOSITES

A Thesis

Major Subject: Aerospace Engineering

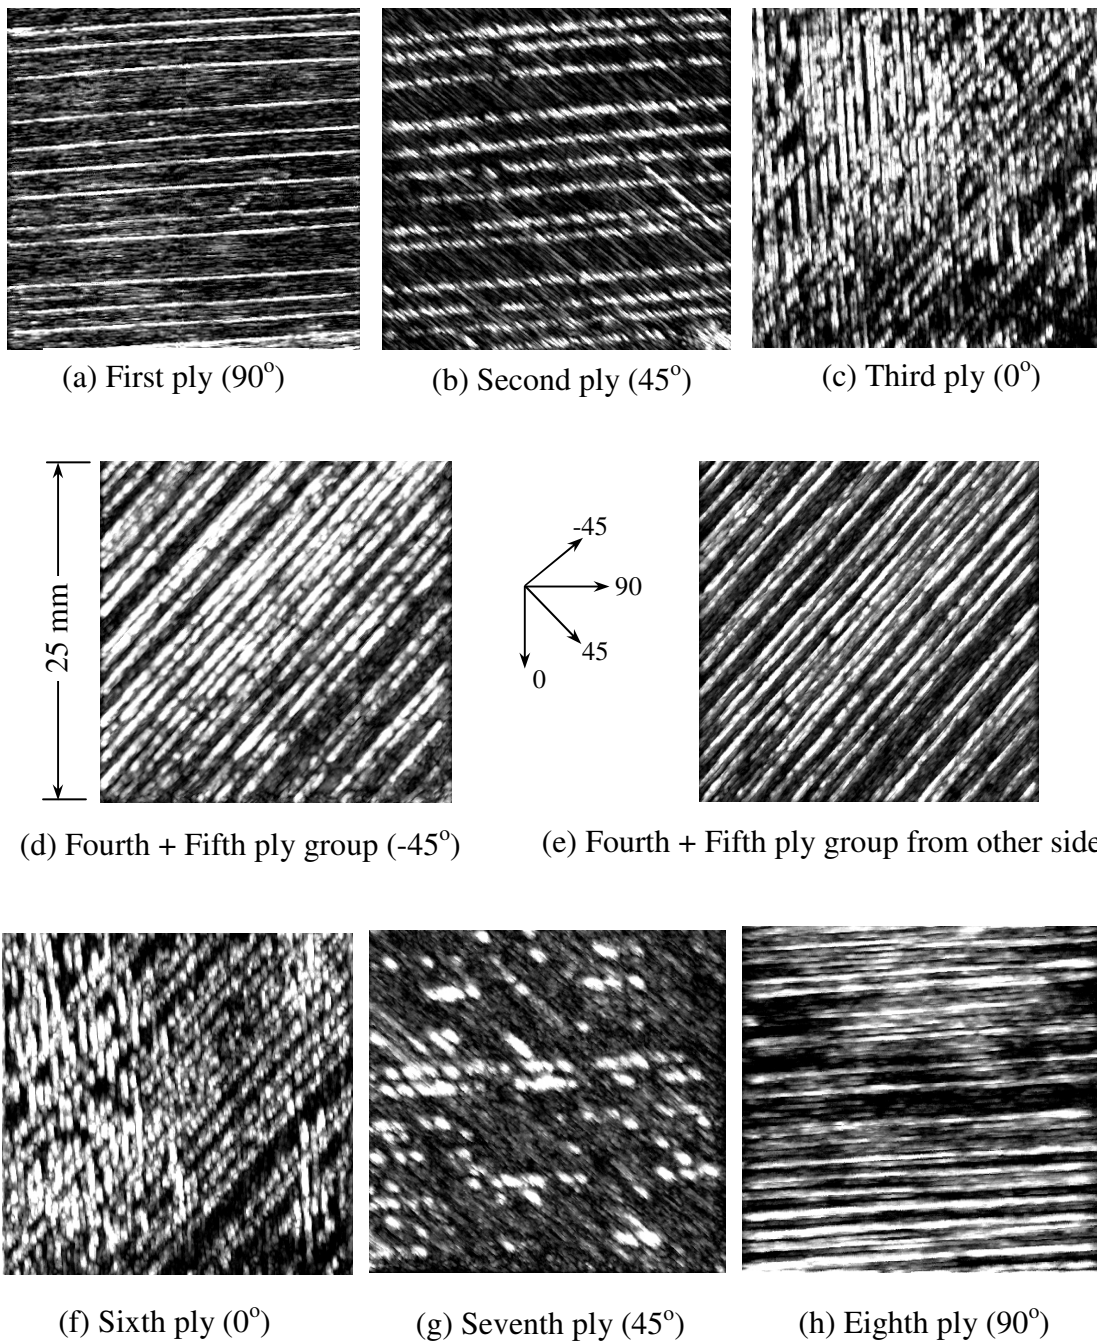
Fig. 3.9 Ultrasonic images of cracks in the eight plies of the $[90/45/0/-45]_s$ TAMU-3 specimen. (Angle of incidence = 25°)

Ply-by-ply ultrasonic NDE results for all the eight plies of the TAMU-2 and the TAMU-3 specimens are presented in Figs. 3.8(a) through (h) and Figs. 3.9(a) through (h) respectively. The liner is on the first ply for both the specimens. Figures 3.10 (a) through (h) show the cracks in all the eight plies of the TAMU-4 specimen. As done earlier in the case of TAMU-1 specimen, in the spirit of self-calibration, the cracks in the -45_2 ply-group of all the three specimens were detected using two different acoustic paths, one

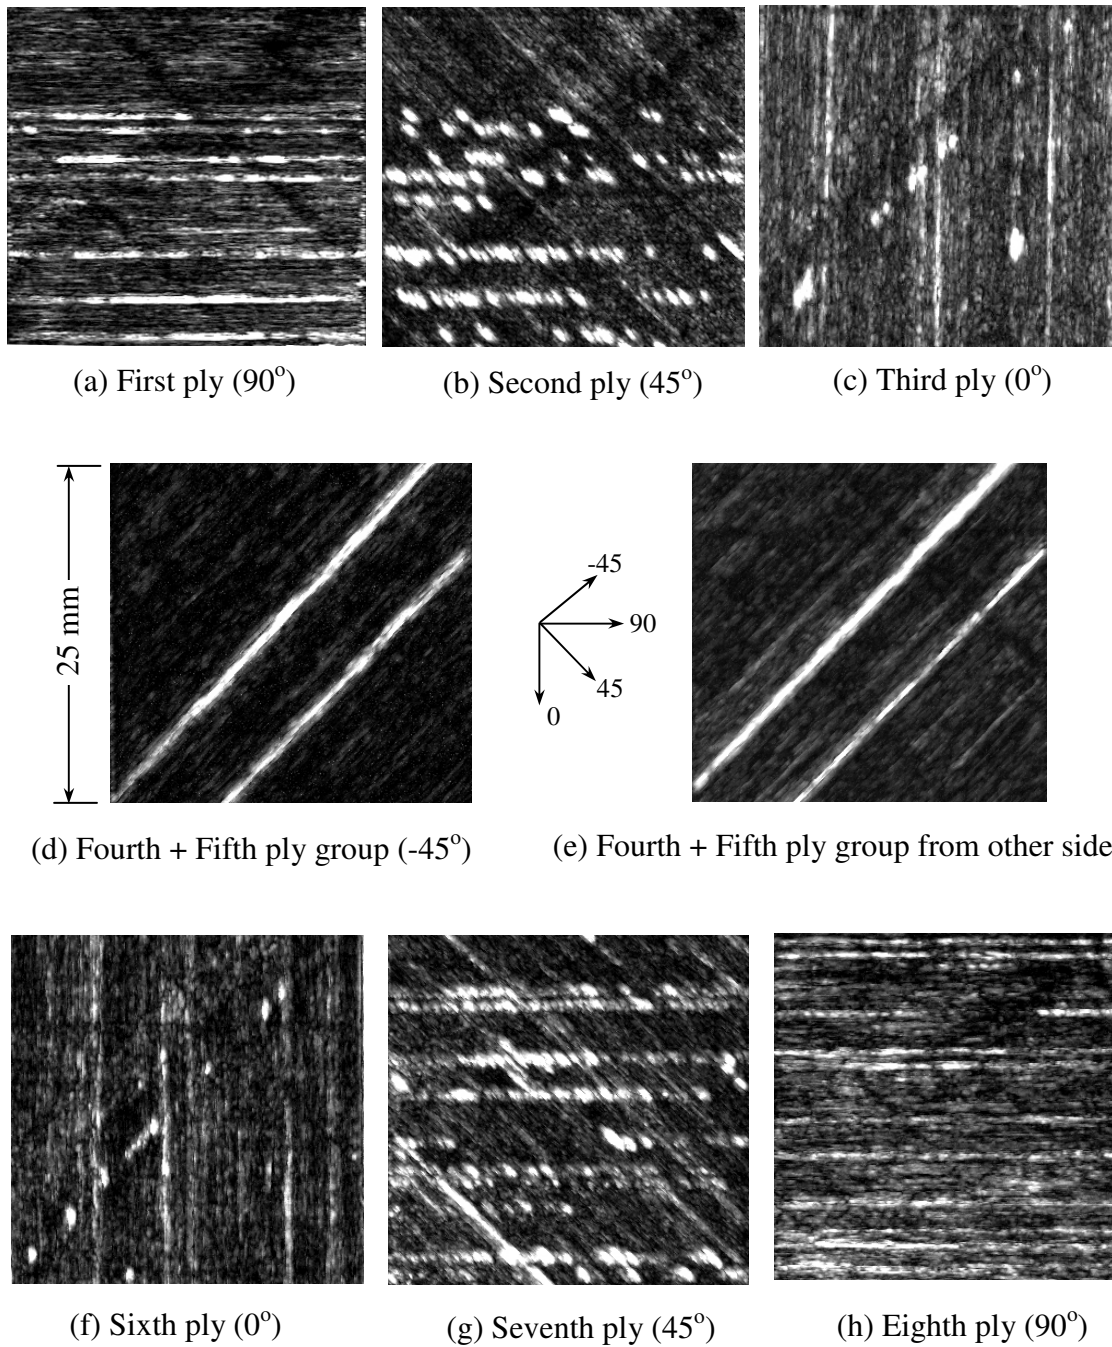
Fig. 3.10 Ultrasonic images of cracks in the eight plies of the $[90/45/0/-45]_s$ TAMU-4 specimen. (Angle of incidence = 25°)

from either side of the specimen. In these specimens too, short cracks were observed in the second, third, sixth and the seventh plies. The same arguments, as put forward for the TAMU-1 specimen, are valid for the short cracks in these specimens.

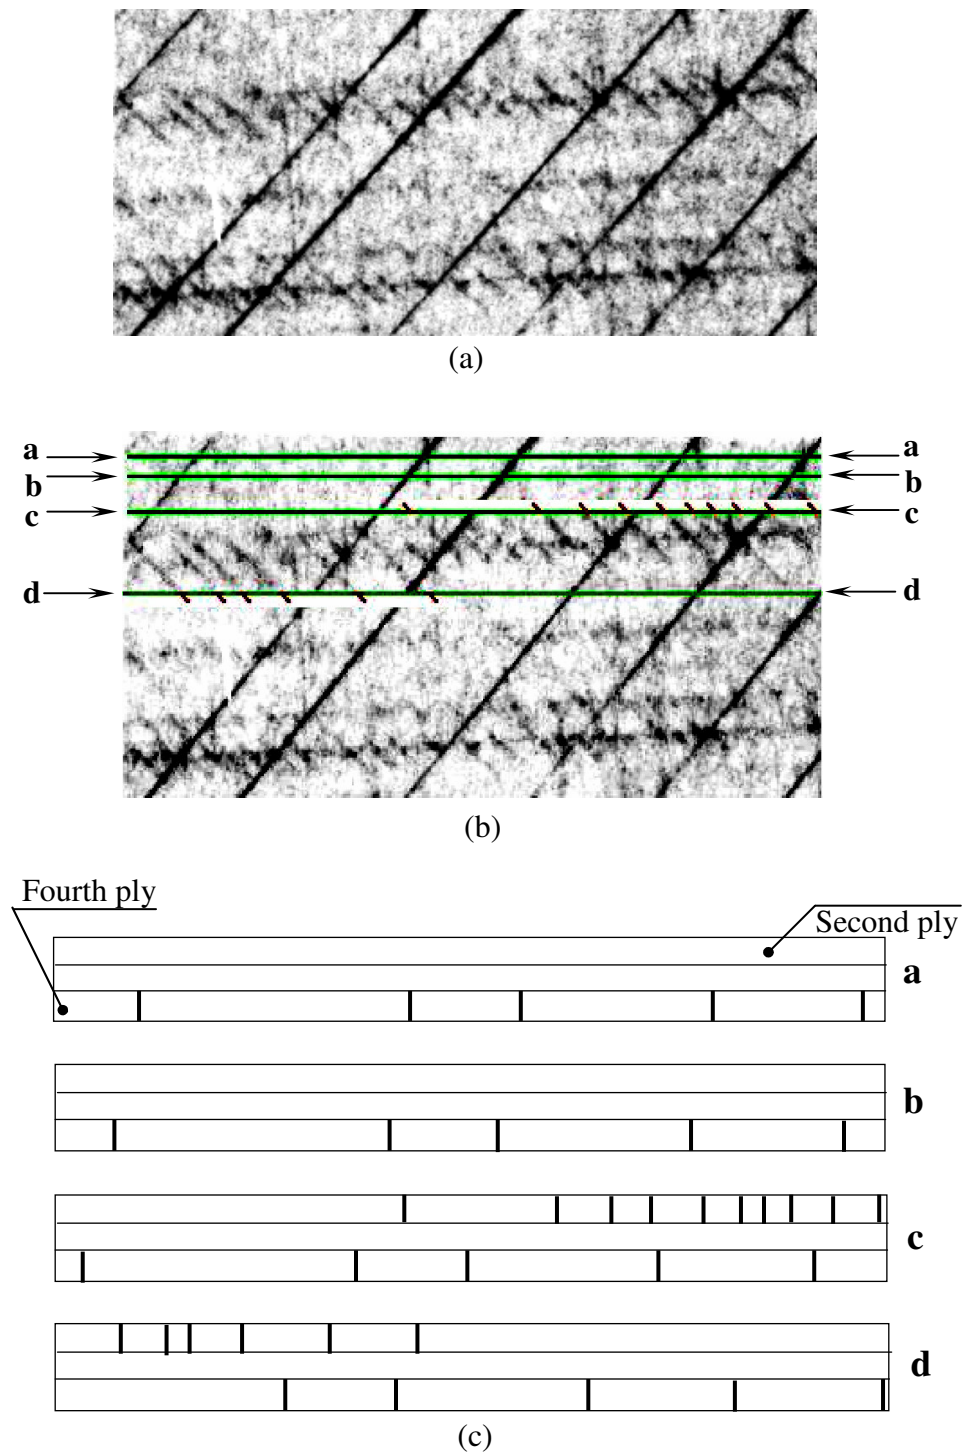
Fig. 3.11 (a) X-ray image showing short cracks in the second ply (45°) of the TAMU-2 specimen, (b) comparison of the results of serial sectioning with the x-ray image, and (c) schematic of the optically detected edge crack positions in the second ply.

In order to further ascertain the presence of short cracks a destructive test of the TAMU-2 specimen was undertaken. Details of this exercise are explained next. For greater clarity and ease of comparison, the optical microscopy results during the destructive test were compared with the X-ray image of the specimen instead of an ultrasonic image. The X-ray image is presented in Fig. 3.11(a). The laminate was first sectioned along the line a-a as shown in Fig. 3.11(b), polished and examined optically at 200X magnification for cracks in the second ply (45°). As expected, the examination of the section along a-a did not reveal any cracks in the second ply. Subsequently, the sample was carefully sectioned along the lines b-b, c-c, d-d and optical examination was repeated in each case. In c-c, some cracks in the second ply appeared. Their positions are presented in Fig. 3.11(b) as tick-marks in the 45° directions. Note that the positions of the optically observed cracks coincides with the positions of dark lines in the x-ray image and when stitch cracks are not seen in the x-ray image they are also not observed in the optical examination. This serial sectioning confirmed the presence of short cracks in the second ply of the TAMU-3 laminate. Since TAMU-1, TAMU-2 and TAMU-4 specimens showed similar damage characteristics as shown by the TAMU-2 specimen, the corroboration of the presence of short cracks in the TAMU-2 essentially confirms the presence of short cracks in the other specimens.

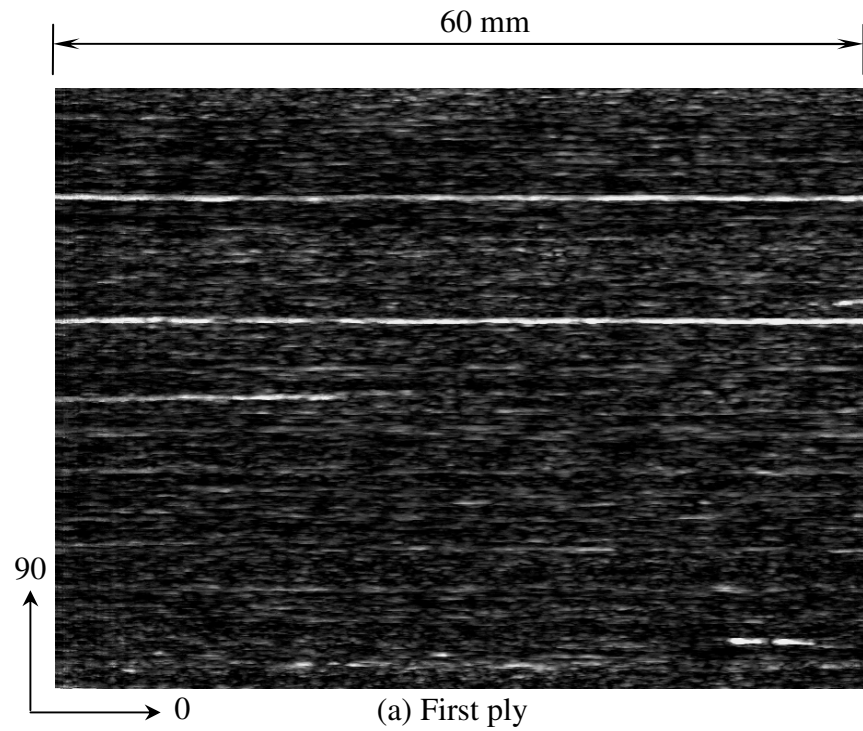
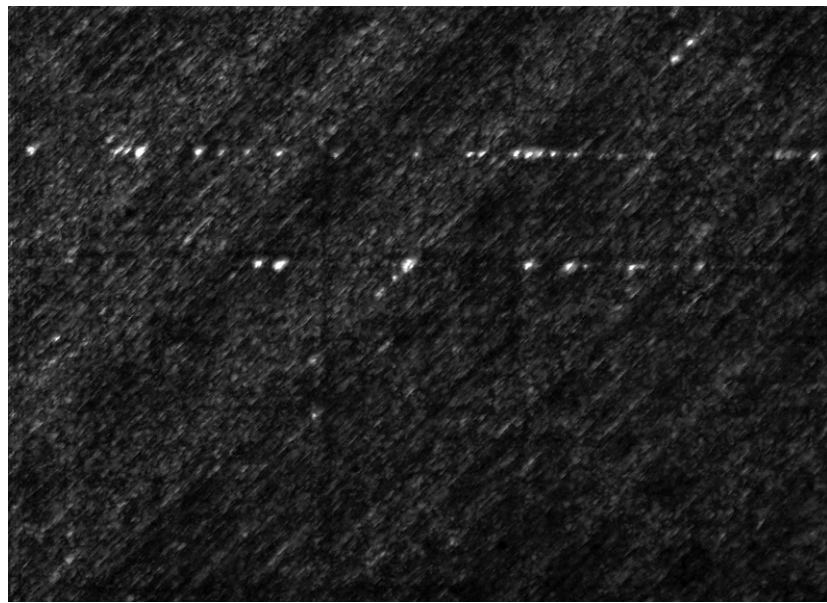
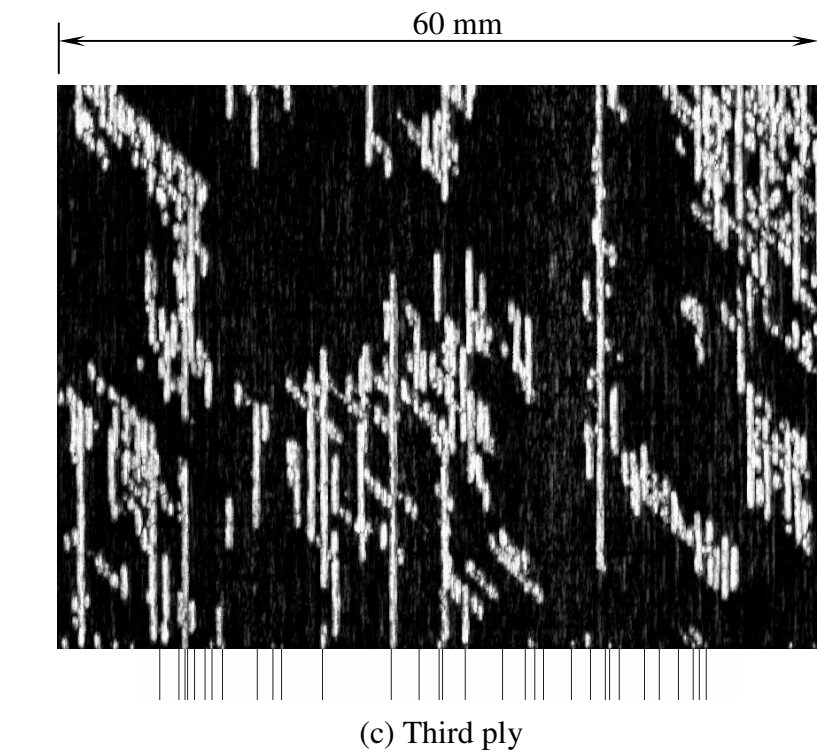
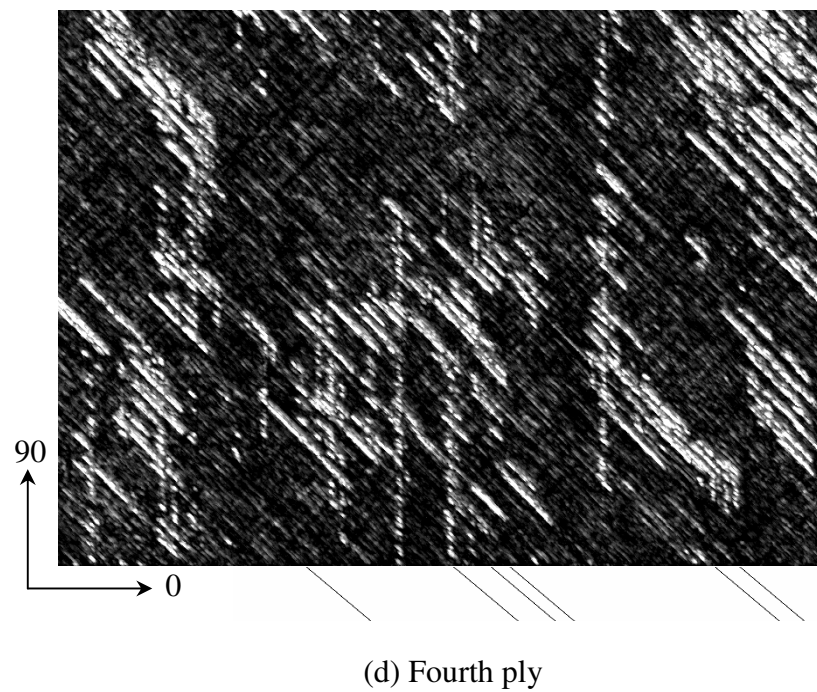
(a) Second ply

Fig. 3.12 Ultrasonic images of matrix cracks in the TAMU-5 specimen.
Cracks in the (a) first ply, (b) second ply.

Fig. 3.12 (continued) Cracks in the (c) third ply and (d) fourth ply of the TAMU-5 specimen. (Schematic of the optically detected cracks is shown at the bottom of the images)

This 18-ply $[0/45/90/-45/0/45/90/-45/0]_s$ laminate was scanned for matrix cracks by a 20 MHz transducer. A ply-by-ply examination of the laminate was conducted with angle of incidence set to 25° . A gate of 400 ns duration from the start of the received signal was used for all the plies. Cracks were found in only the first ply (0°), the second ply (45°) third ply (90°) and the fourth ply (-45°) orientation. Figures 3.12(a) through (d) show the matrix cracks in the first, second, third and the fourth plies respectively. It can be observed from a comparison of Fig. 3.12(a) with 3.12(b), that the short cracks in the second ply (45°) are aligned along the long cracks in the sparsely damaged first ply (0°). From Fig. 3.12(c) and Fig. 3.12(d) it is clear that most of the matrix cracks in the third and the fourth plies are either internal or partial cracks. It is noted that, in certain areas in Fig. 3.12, the short cracks in the third ply are driven by cracks in the fourth ply, whereas in other portions the short cracks in the fourth ply are driven by cracks in the third ply. It is also interesting to note that though the arrangement of cracks in the third ply greatly influenced the pattern of crack formation in the fourth ply, it did not have any influence on the crack pattern in the second ply.

The results obtained by using X-radiography for the same area as shown in Fig. 3.12 have been presented earlier in Fig. 2.32. It is interesting to note that, X-radiography did not yield any information about the cracks in any of the four damaged plies. Also, from the schematics of the optically detected cracks in Figs. 3.12(c) and 3.12(d), it is clear that optical microscopy could detect only a small number of cracks visible at one of

the edges. This case is a glorious example demonstrating the advantages the ultrasonic ply-by-ply crack detection technique over X-radiography and optical microscopy.

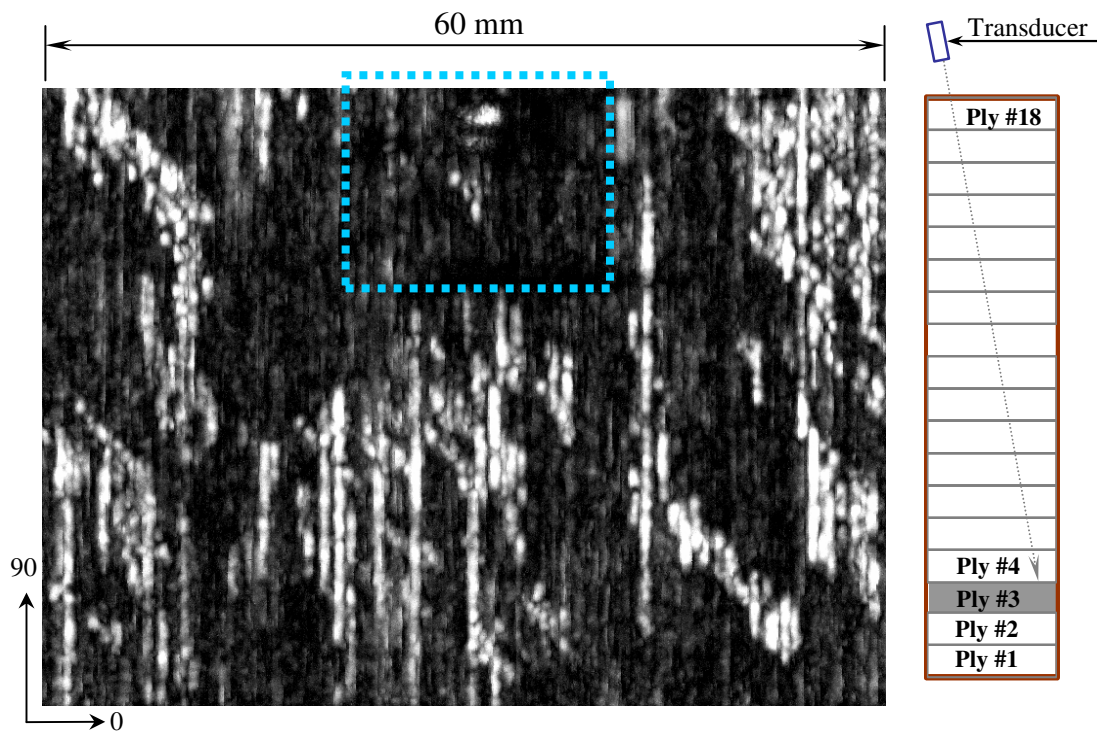
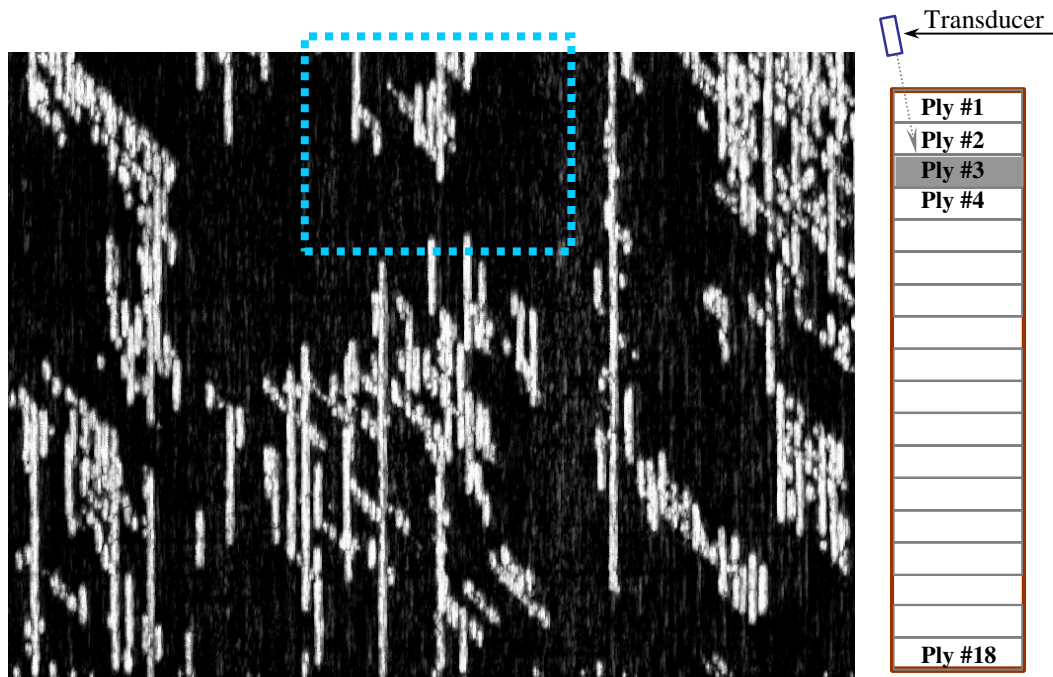
(a) Cracks in the third ply as detected through fifteen plies

(b) Cracks in third ply as detected through two plies

Fig. 3.13 Ultrasonic image of matrix cracks in the third ply of the TAMU-5 specimen obtained by using two different acoustic paths. (Angle of incidence = 25°)

For the sake of clarity of communication, in the following, the first through fourth plies in the above discussion will be referred to as Ply #1 through Ply #4 respectively. In another experiment, the specimen was flipped over and again scanned for matrix cracks in the Ply #1 through Ply #4 from the other side. Obviously, after flipping over, the interrogating acoustic beam has to travel through 17 plies in order to detect the cracks in Ply #1 (0°); through 16 plies to detect the cracks in the Ply #2 (90°) and so on. This is schematically shown in Figs. 3.13 and 3.14. Though, a weaker reflected field was observed than in the previous case, the cracks in the two plies could still be detected. The signal to noise ratio was found to be about 15 dB. The resulting images of cracks in Ply #3 and Ply #4 are shown in Fig. 3.13(a) and Fig. 3.14(a) respectively. For the purpose of comparison, the corresponding images obtained earlier, when the acoustic beam traveled through two plies for Ply #3 (Fig. 3.12(c)) and through three plies for Ply #4 (Fig. 3.12(d)), are reproduced in Fig. 3.13(b) and Fig. 3.14(b) respectively. Comparing the areas marked by dotted rectangles in Figs. 3.13(a) and 3.14(a) with 3.13(b) and 3.14(b) respectively, it is seen that the cracks in the marked area in the Ply #3 and Ply #4 were not detected after flipping. This was because, after flipping, the presence of a strain gauge on the top-most ply blocks the interrogating acoustic beam from reaching the interior plies. A photograph of the corresponding area of the TAMU-5 specimen (again marked by a dotted rectangle), showing the strain gauge, is presented in Fig. 3.15.

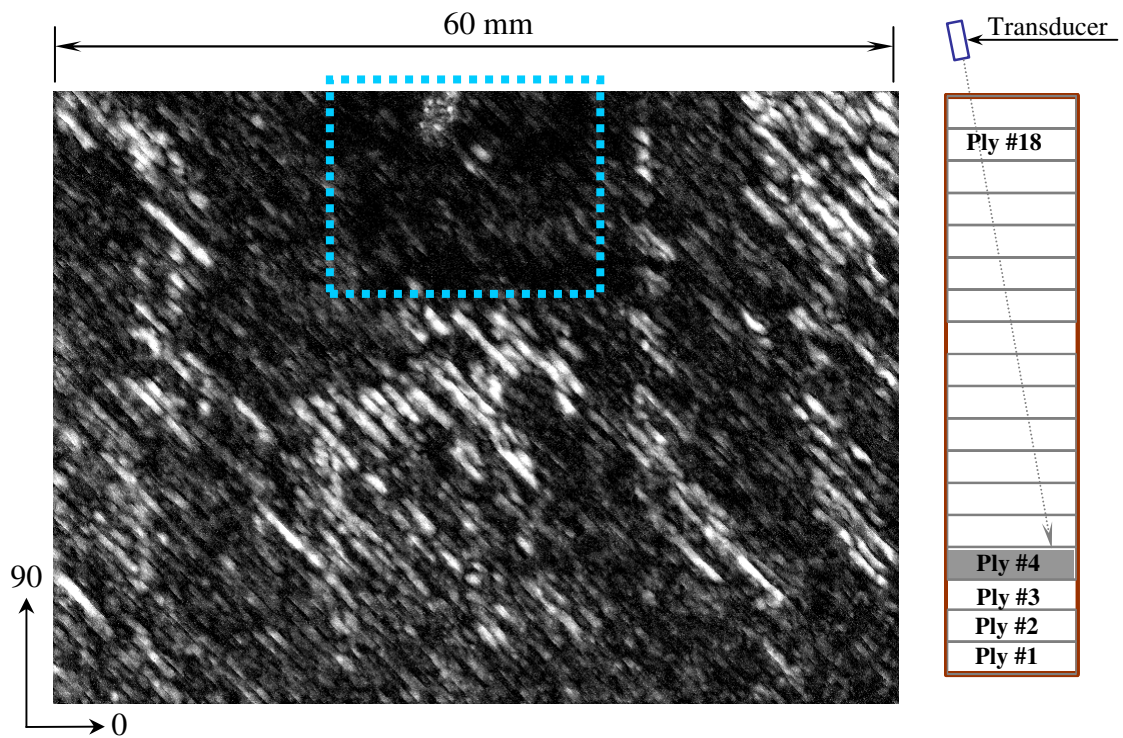
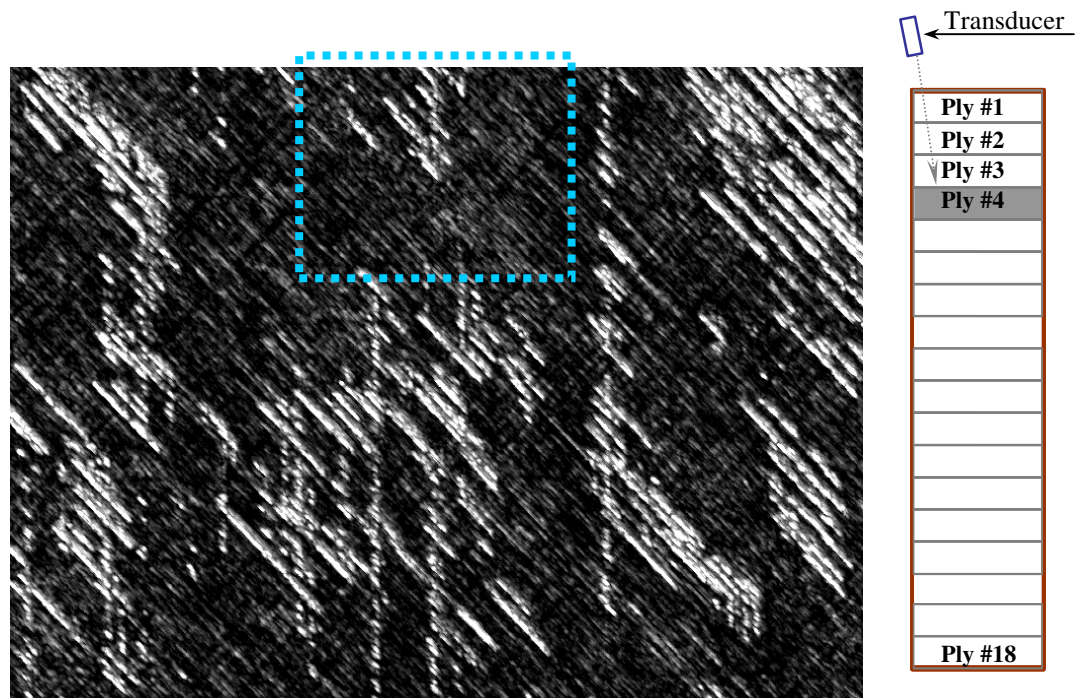
(a) Cracks in the fourth ply as detected through fourteen plies

(b) Cracks in the fourth ply as detected through three plies

Fig. 3.14 Ultrasonic image of matrix cracks in the fourth ply of the TAMU-5 specimen obtained by using two different acoustic paths. (Angle of incidence = 25°)

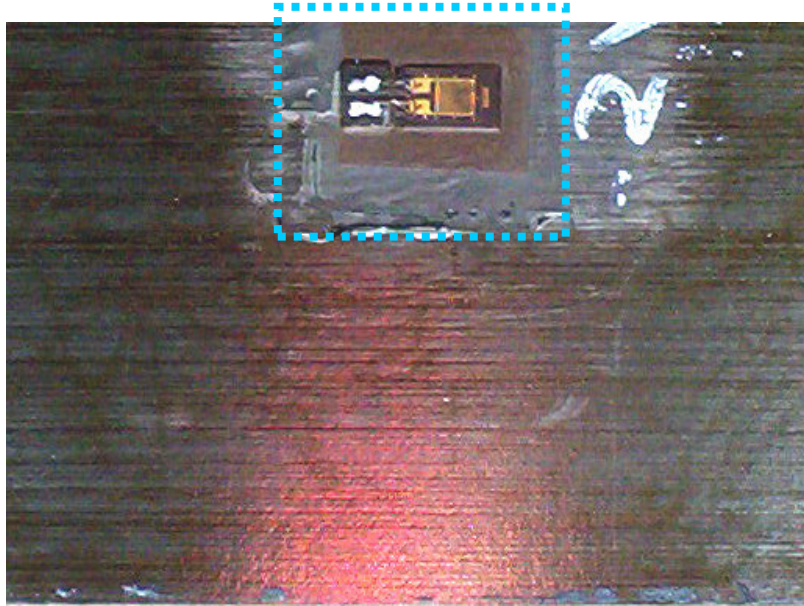
Fig. 3.15 A photograph of the TAMU-5 specimen showing the strain gage.

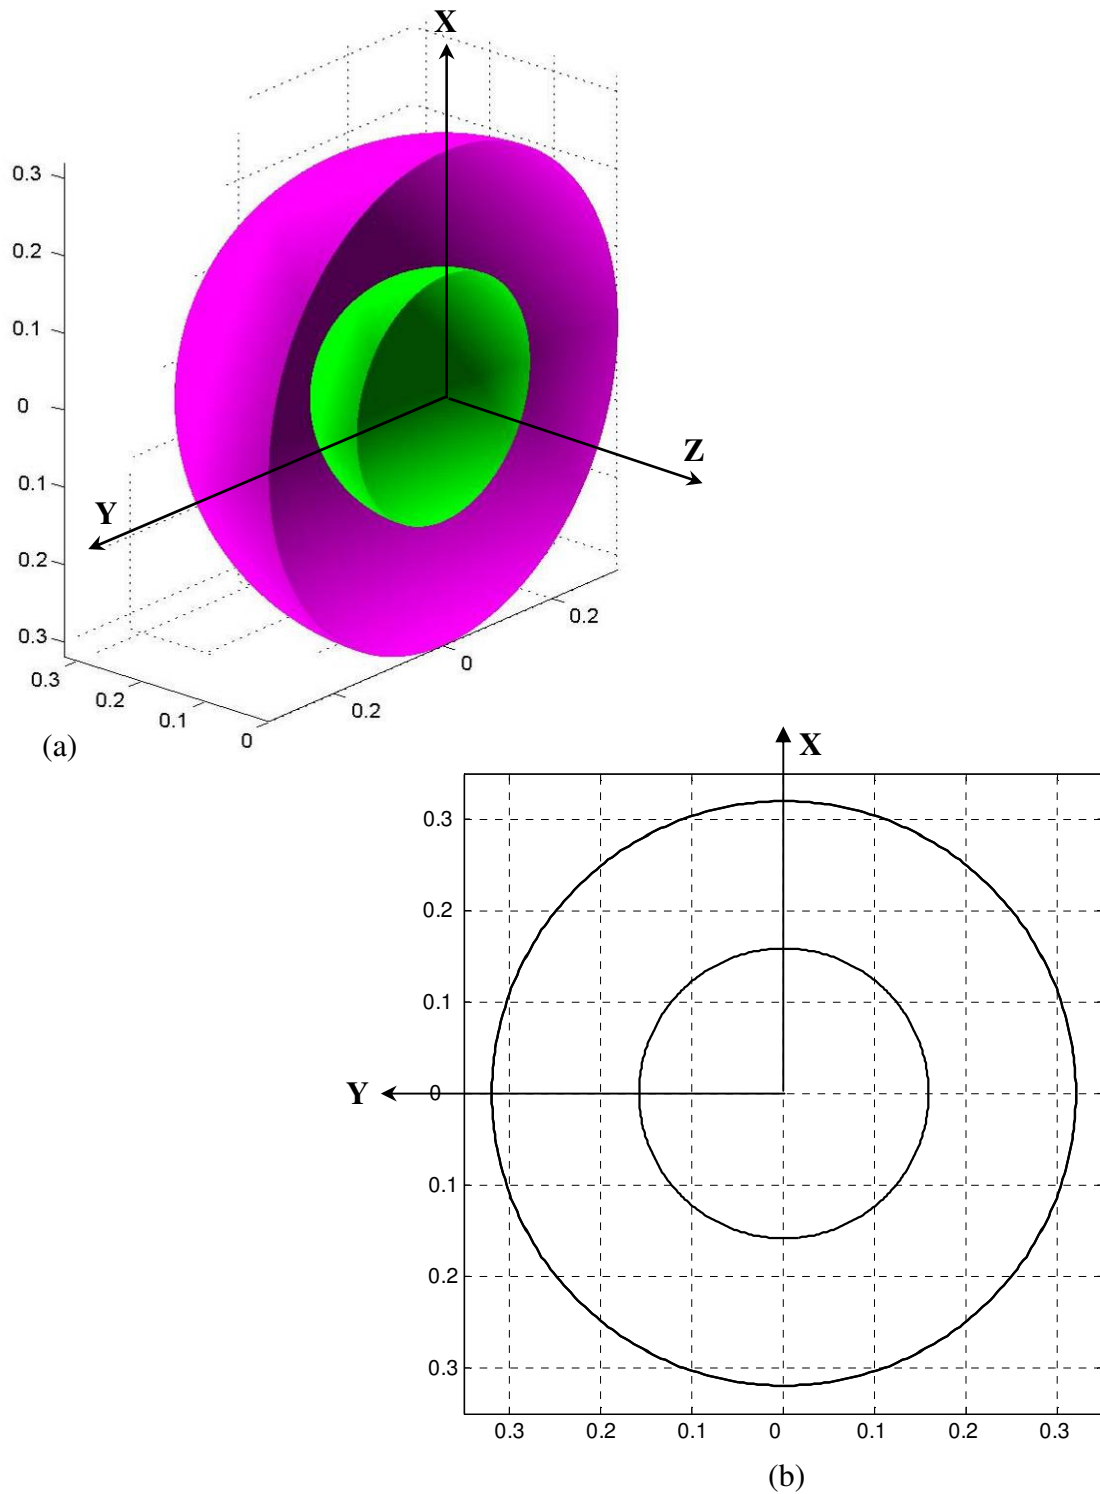
Fig. A-1 Slowness surface for aluminum. (a) 3-dimensional view, (b) Intersection of the surface with the X_1 - X_2 plane. The inner surface corresponds to the longitudinal wave and the outer surface corresponds to the shear waves. Values are in s/mm.

For an isotropic material, for each wave, the phase velocities are independent of the direction of propagation giving rise to spherical slowness surfaces. Two eigenvectors degenerate to one, and any direction normal to \mathbf{n} becomes an admissible eigenvector. As an example, the 3-dimensional slowness surfaces were calculated for aluminum and are illustrated in Fig. A-1(a). In an effort to reveal the nature of these surfaces, only half of the spherical surfaces are shown. The inner surface corresponds to the P wave and the outer surface corresponds to both the shear (SV and SH) waves. Intersection of the velocity surface with the X_1 - X_2 plane is shown in Fig. A-1(b). The stiffness matrix for aluminum used in the calculations is shown in equation (A.14) [29].

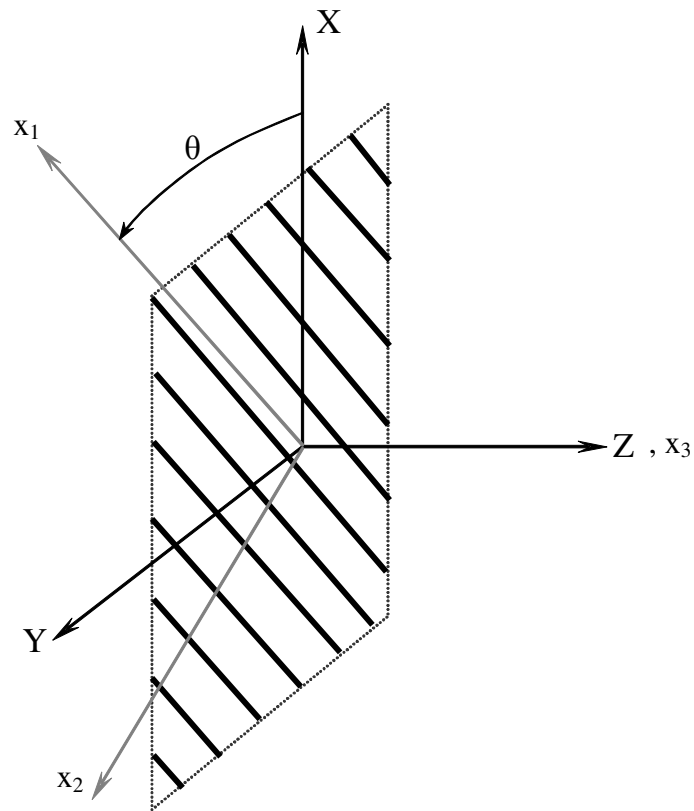
Fig. A-2 Definition of local (x_1 - x_2 - x_3) and global (X - Y - Z) coordinate systems with respect to a unidirectional fiber-reinforced lamina.

Laminated composites are made by stacking together individual unidirectional fiber-reinforced plies. Each ply consists of fibers oriented in a particular direction. Two orthogonal co-ordinate systems are chosen in such a way that the X-Y-Z define the laminate (global) coordinates and x_1 - x_2 - x_3 define the material (local) co-ordinates at the ply level. This is shown in Fig. A-2. In the material co-ordinate system, the fibers are generally chosen to be along the direction of the x_1 -axis. The Z-axis and the x_3 -axis are perpendicular to the plane of the laminate. The angle θ defines the rotation of the material co-ordinate system about the Z-axis i.e. θ is the orientation of fibers in a given ply.

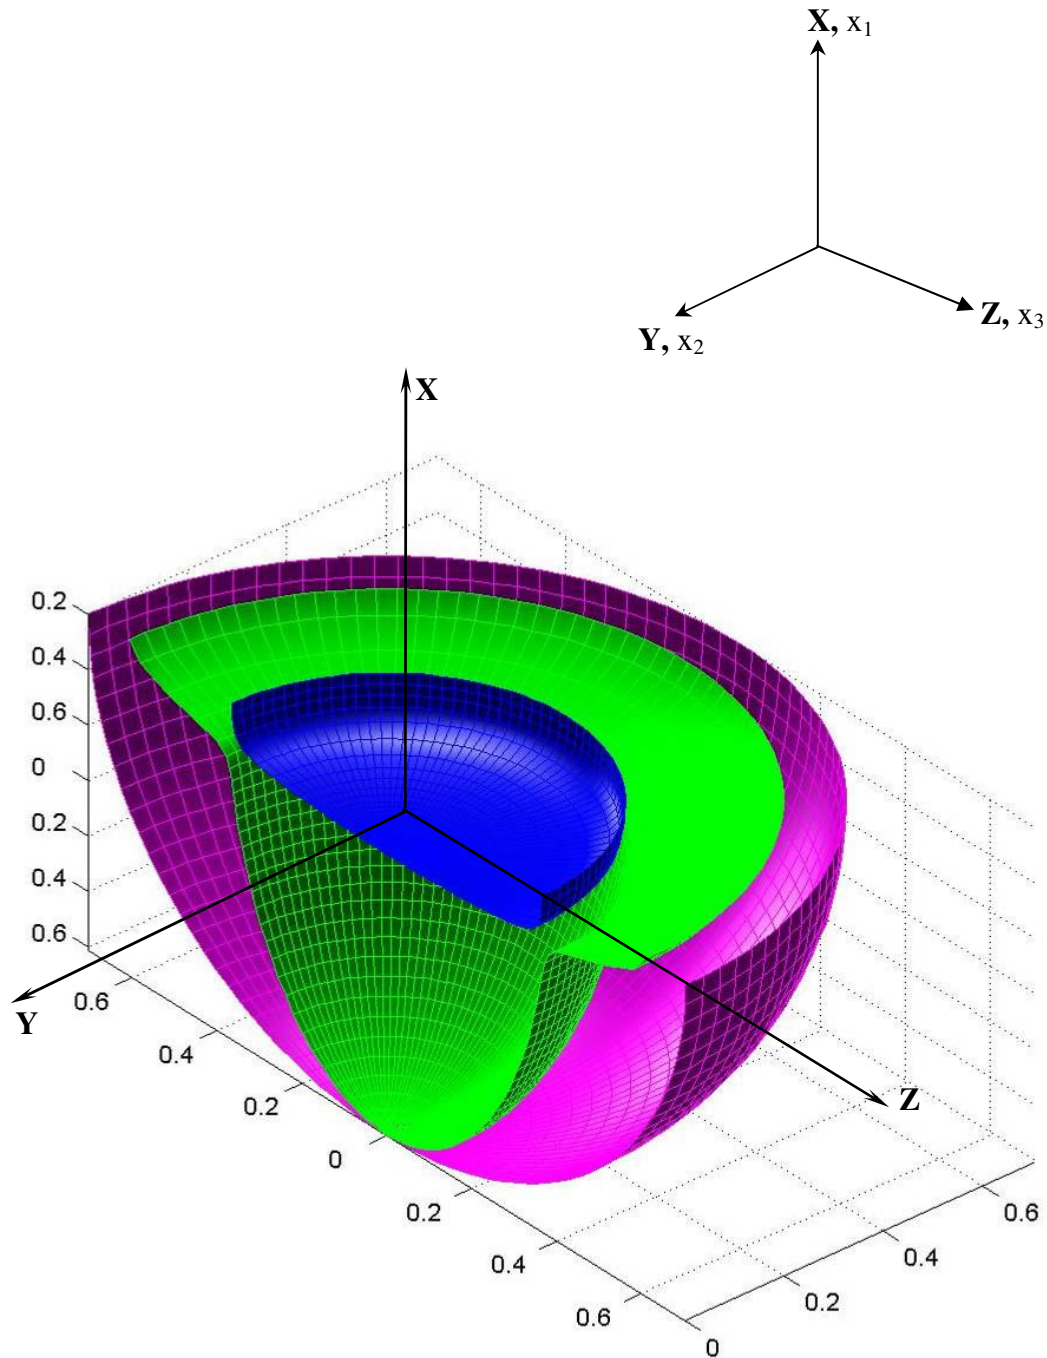
Fig. A-3 Slowness surfaces for a 0° ply. The innermost surface corresponds to the P-waves, the next surface corresponds to the SV waves and the outermost surface corresponds to the SH waves. Values are in units of s/mm.

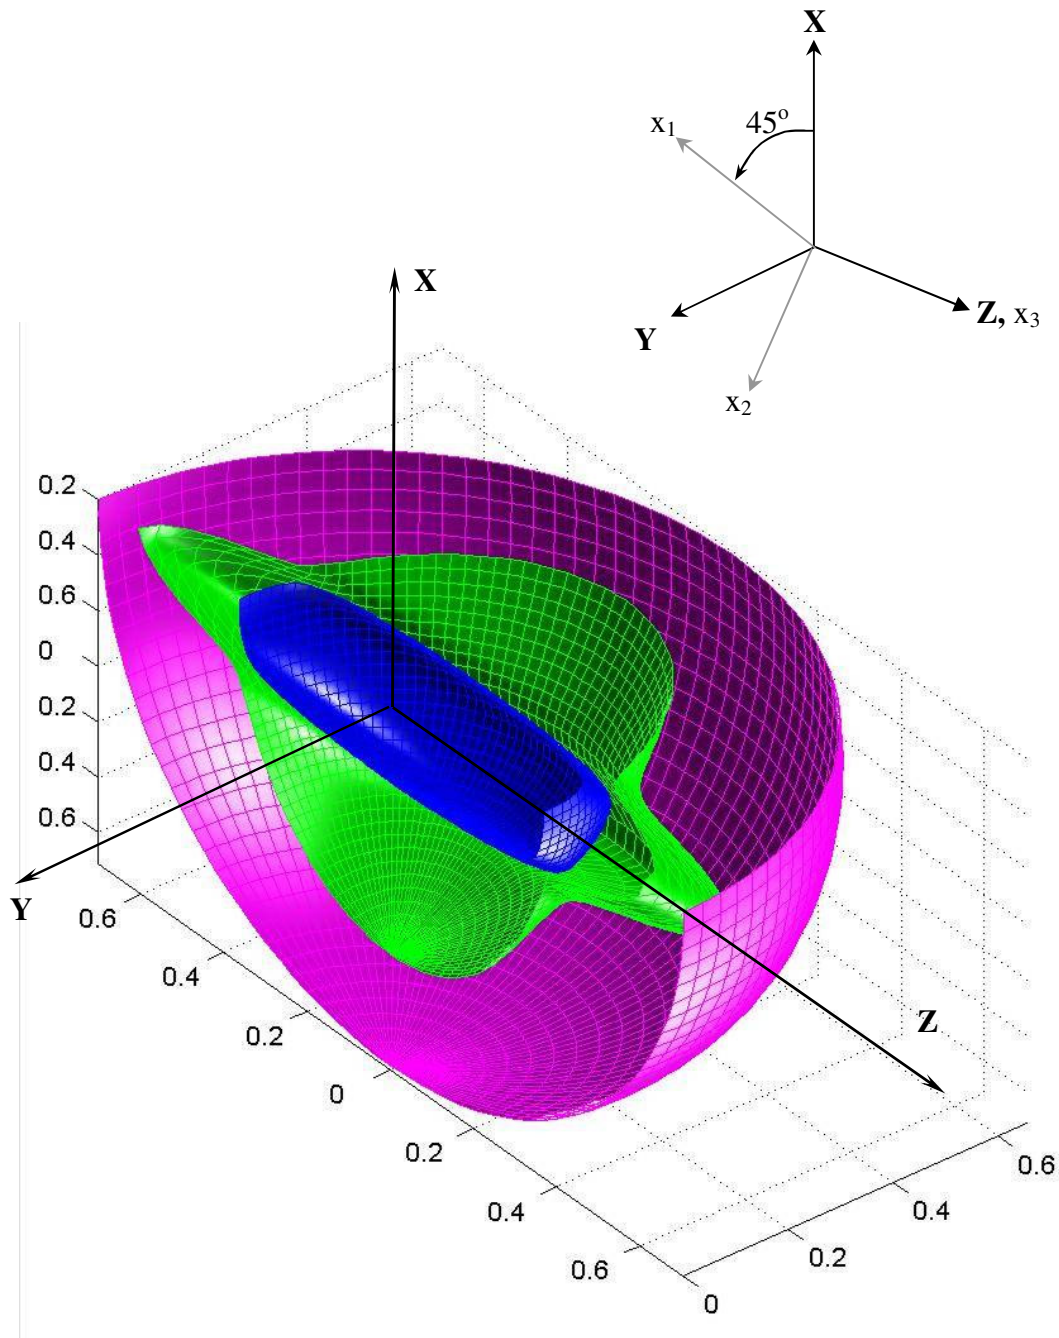
Fig. A-4 Slowness surfaces for a 45° ply. The innermost surface corresponds to the P-waves, the next surface corresponds to the SV waves and the outermost surface corresponds to the SH waves. Values are in units of s/mm.

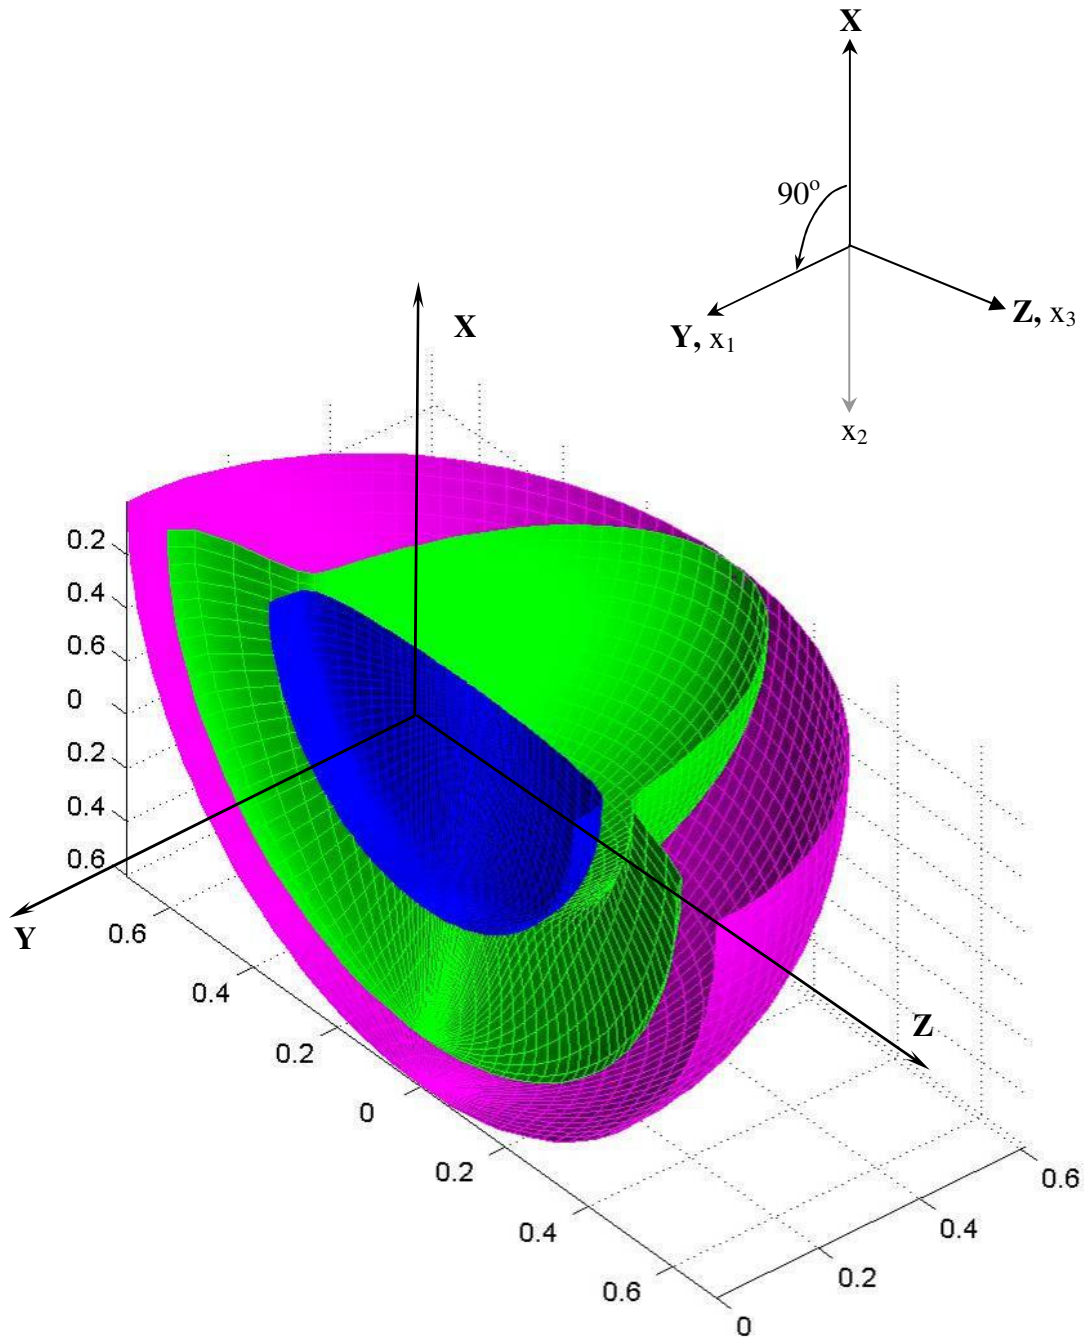
Fig. A-5 Slowness surfaces for a 90° ply. The innermost surface corresponds to the P-waves, the next surface corresponds to the SV waves and the outermost surface corresponds to the SH waves. Values are in units of s/mm.

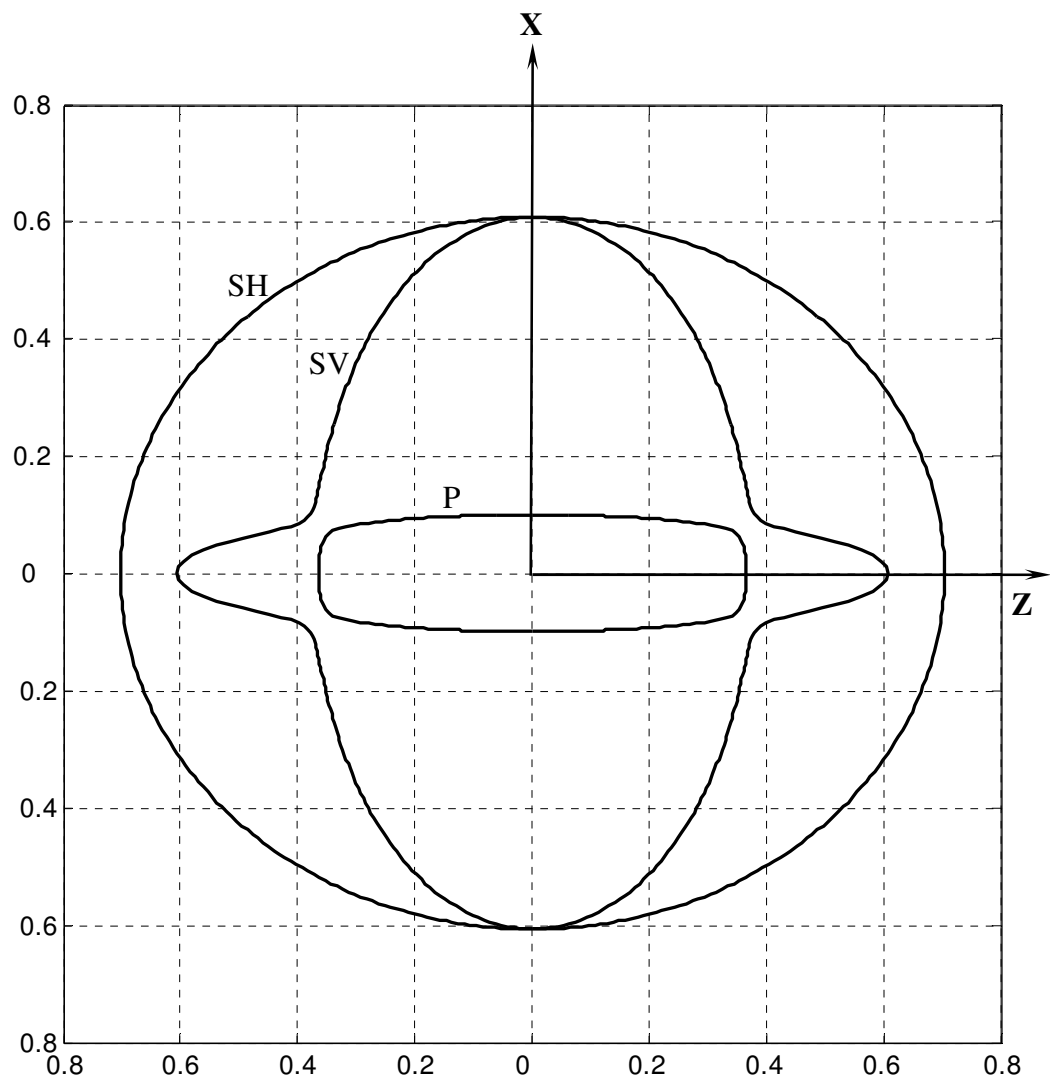
Fig. A-6 Slowness diagram for a 0° ply as seen on the X-Z plane.
Values are in units of s/mm.

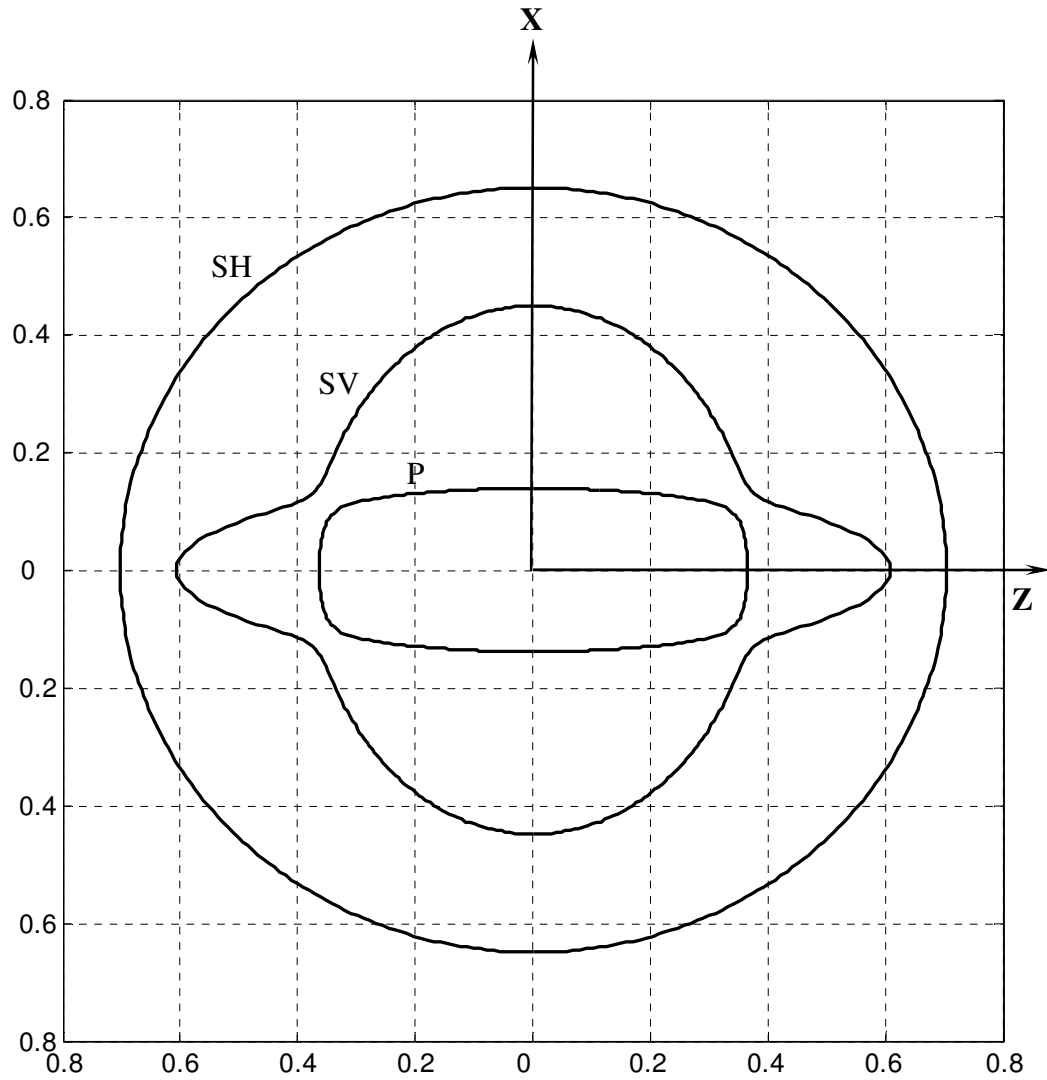
Fig. A-7 Slowness diagram for a 45° ply as seen on the X-Z plane.
Values are in units of s/mm.

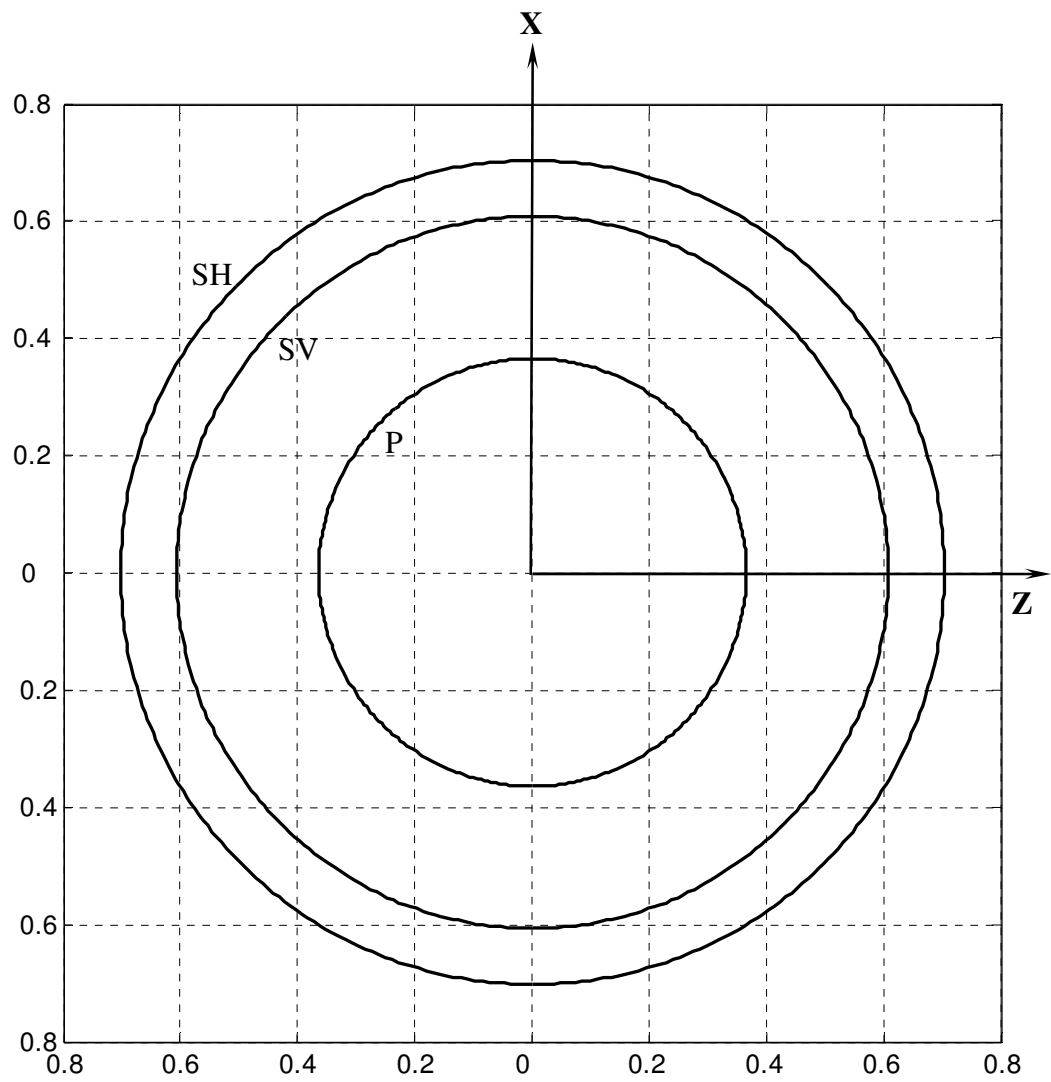
Fig. A-8 Slowness diagram for a 90° ply as seen on the X-Z plane.
Values are in units of s/mm.

slowness profile (called slowness diagram) is generally used. This is done by setting $\psi = 0$ in equation (A.16) and rotating \mathbf{n} for all values of ϕ . Fig. A-6, Fig. A-7 and Fig. A-8 show the 2-dimensional slowness profile for plies oriented at 0° , 45° and 90° respectively.
